Damage Assessment and Reconstruction Planning in Poggio Picenze, following L'Aquila 2009 earthquake

Vincenzo Sepe, Enrico Spacone

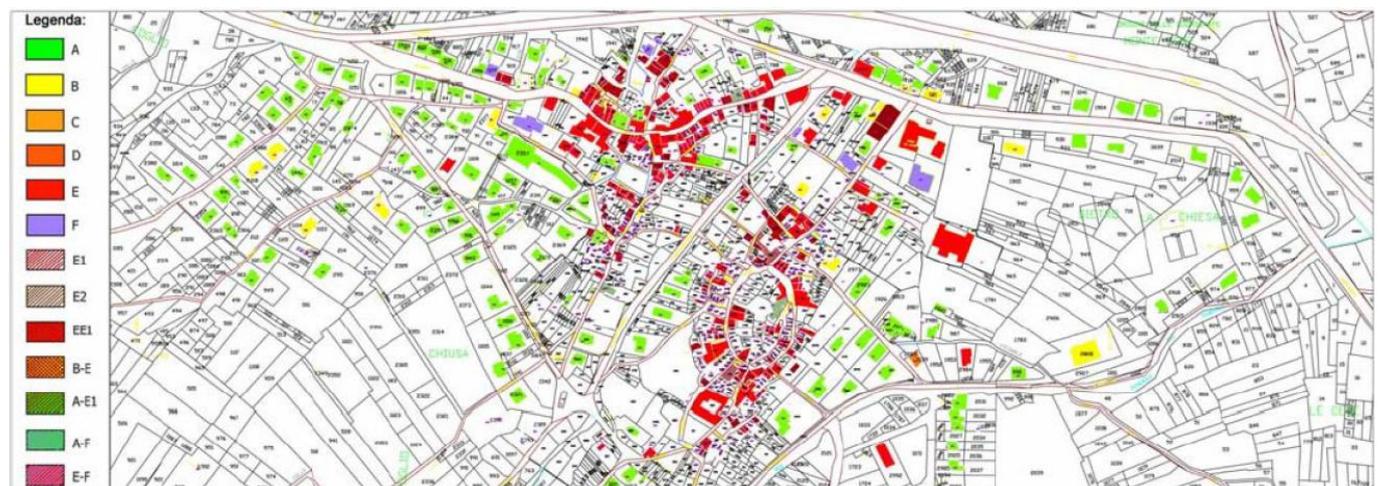
Figure 2. Close-up of the results of the past-earthquake damage survey in Poggio Picenze

The results of this survey, carried out by hundreds of volunteers (civil engineers, architects, geologists) coordinated by the DPC, were reported on the map section of Poggio Picenze (Fig. 2). The red areas clearly show that the two village oldest cores of are almost completely inhabitable and for this reason the old historical center has been closed off.

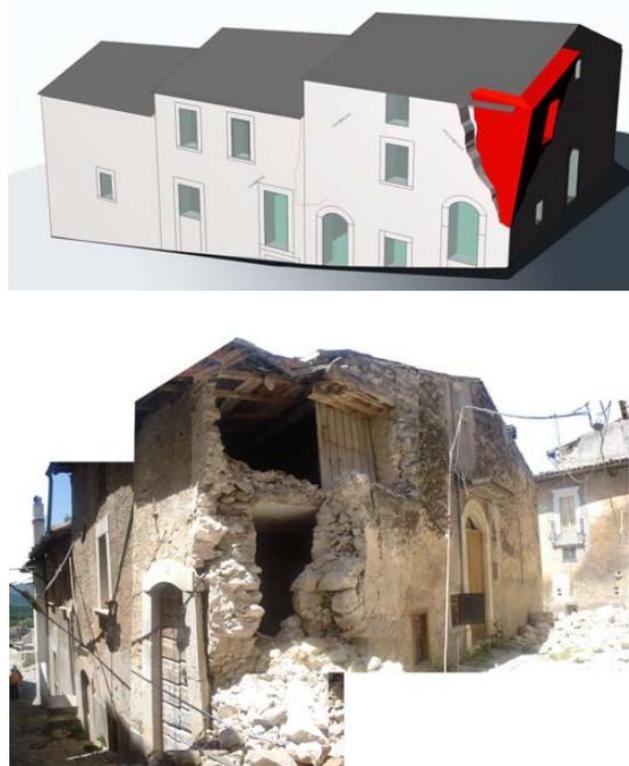
Figure 3. Corner toppling

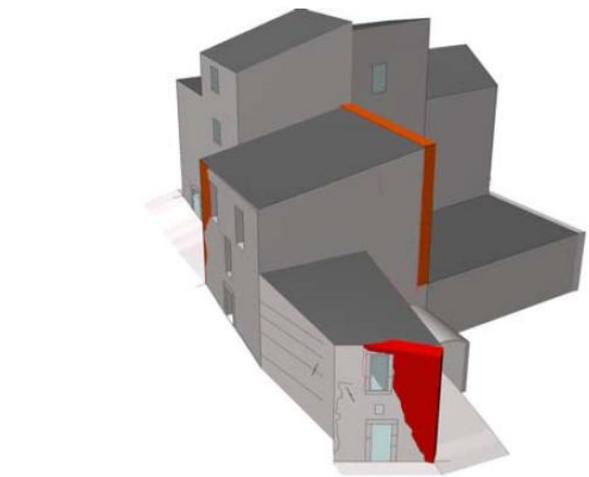
Figure 5. Partial toppling of an external wall

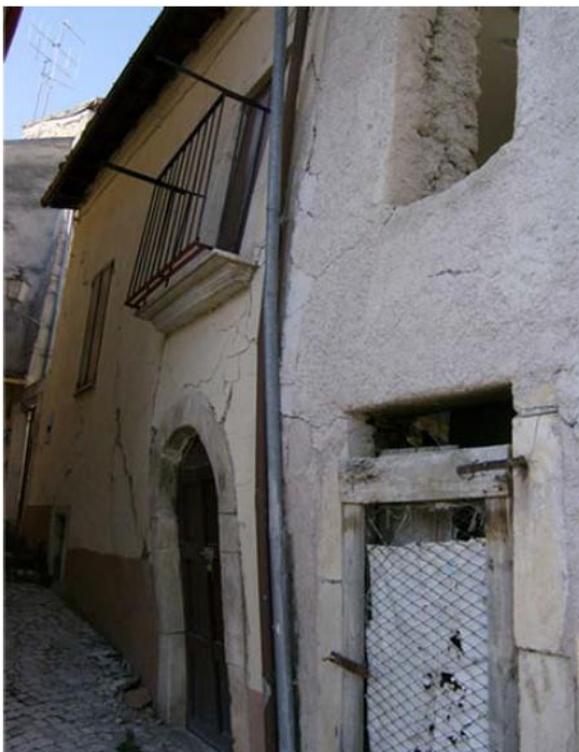
Figure 4. Vertical “bending” of a wall

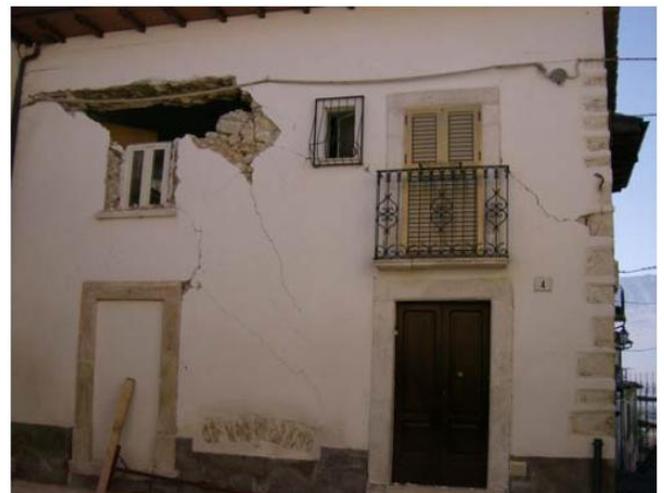
Figure 6. Damage due to excessive shear stress

strength of the buildings depends on the masonry strength. Figure 6 report typical cracks due to excessive shear stress, observed in P. Picenze.

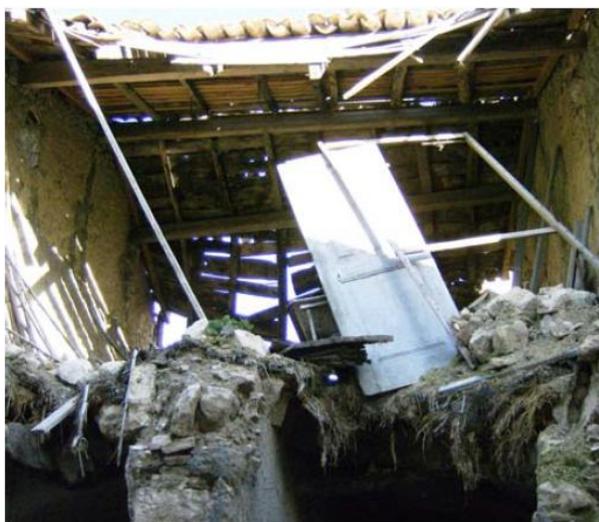
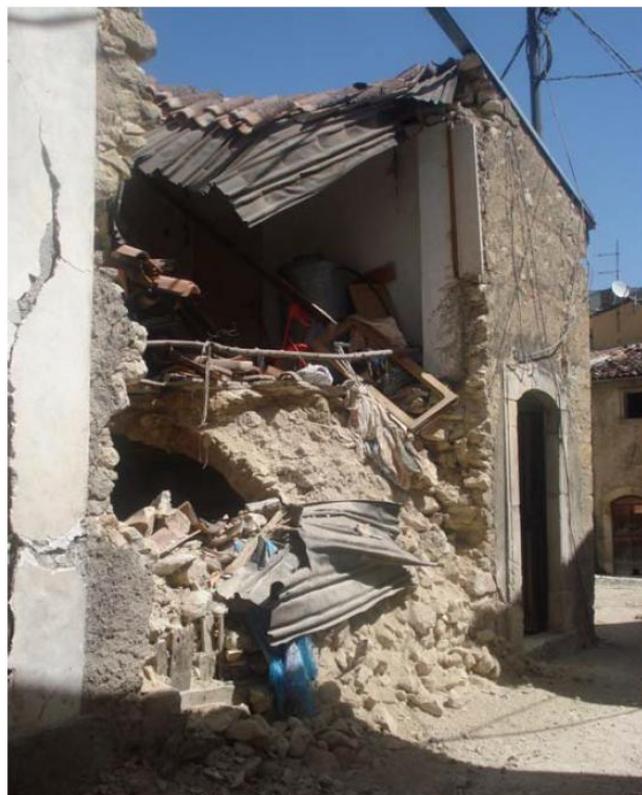
Damage to floor slabs and vaults was also frequently observed (samples in fig. 7.)

Figure 7. Damage due to floor slab and vault collapse

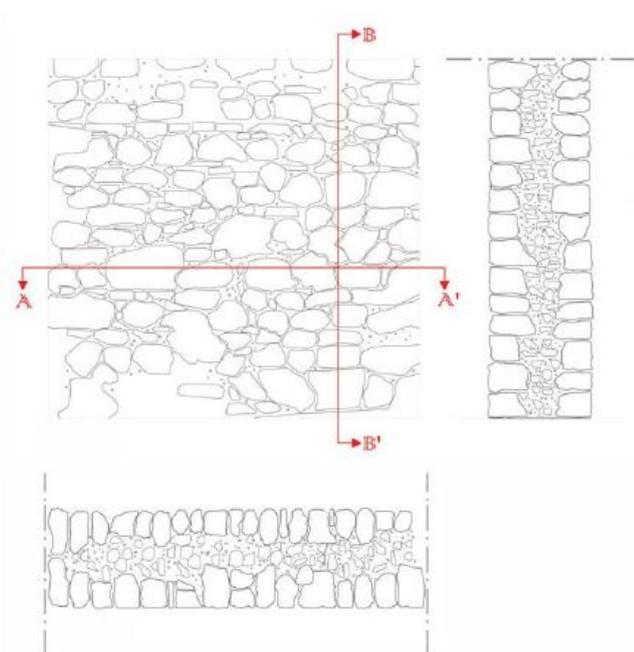
Figure 11. Example of irregular masonry wall

From the technological point of view, the historical buildings are mainly characterized by irregular masonry of natural stones, sometimes with the inclusion of bricks or even roof tiles (Fig. 11). At the lower building levels, masonry vaults are usually found, with a very elementary geometry (barrel vaults), while wooden floor slabs are more frequent in the upper levels.

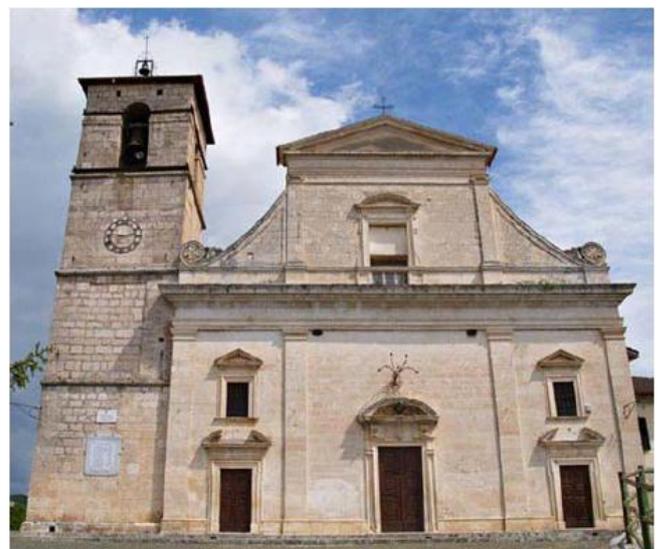
Figure 12. The Church of San Felice Martire

The observed damage typologies include: toppling of the main façade (made of white limestone) and the consequent damage to several decorative elements; the expulsion of stones along the West side of the church; the breaking of the East side of the transept as a consequence of pounding.

Toppling was also observed of some of the walls of the bell tower, with expulsion of stones.

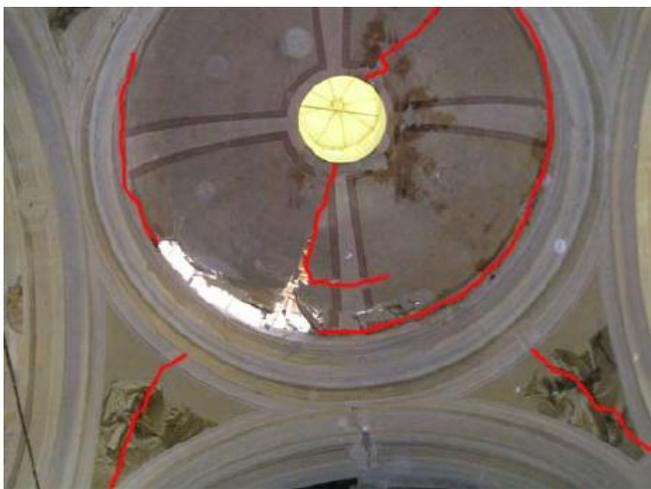
Figure 13. The Church of San Felice Martire

The inner part of the church, decorated according to the baroque style, shows many deep cracks in correspondence of the barrel vault of the apse and the rubble stone walls of the side naves. Collapses were also observed in the dome and in the vaults (fig. 13) of the main and of the lateral naves.
