Edifice A of the Engineering Faculty of L'Aquila: earthquake damage scenario assessment through nonlinear analyses

Alfredo M. Ceci, Vincenzo Gattulli, Francesco Potenza

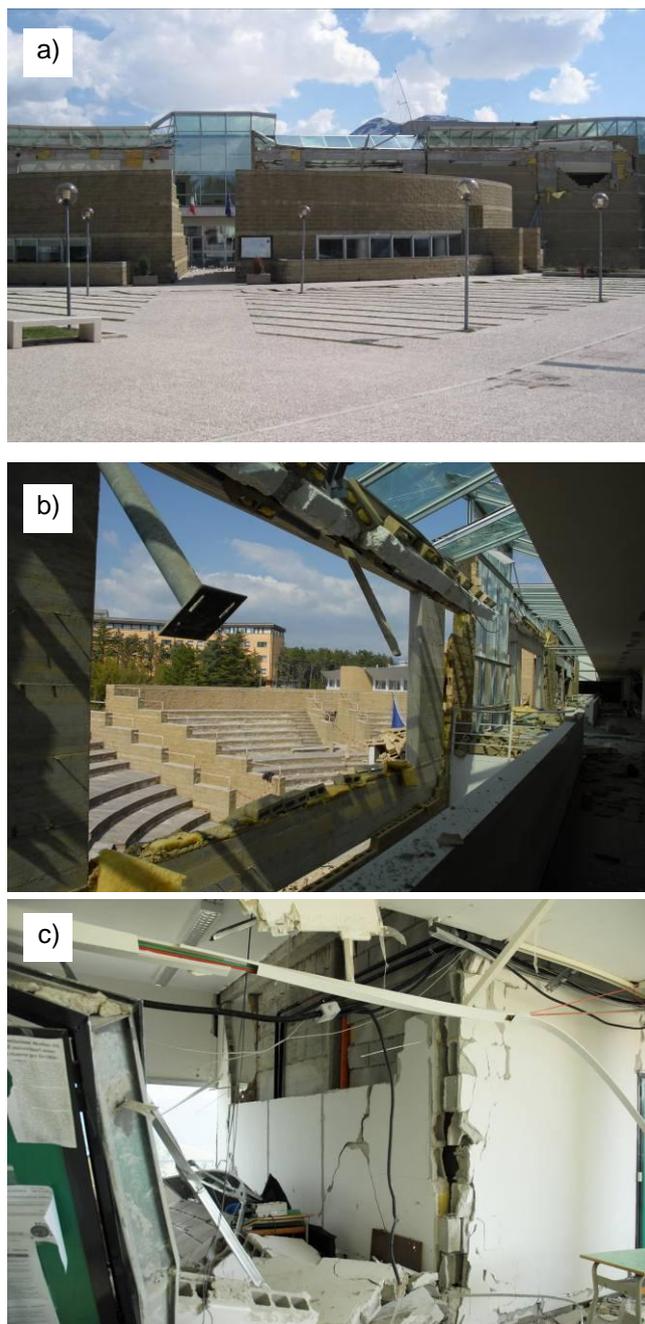
Figure 2. The damages scenario after the mainshock: (a) damages on the principal facade visible from the Campus entrance; (b) damages on the covering glass sheets and the metallic tubulars; (c) overturning and shear cracks on the internal partition walls.

The cover glass sheets and the metallic frames were collapsed, probably due to both the relative motion between the planar frames and the principal substructures and the overturning of the walls which supported the structure on the facade-side.

While the external substructures (A1, A2 and A6) were softly damaged, the highest level were visible on A3 and A4; in particular in the last two floor, starting from the entrance, where the transversal length of the edifice were reduced. Internally, in A3 and A4, the transversal partition walls, which did not oppose significant resistance to the drift motion, presented X-shape cracks. The longitudinal partition, which divided the classrooms from the common areas, overturned.

Finally a large glass sustained by a metallic frame were installed longitudinally, to cover the gap between the facade and the remained structures. Even though it appears as unique building, the Edifice A is composed by seven independent RC substructures (A1-A7), with adequate seismic joints. Each substructure has significant irregularities in the geometry characteristics, mass and stiffness distribution. The principal facade covering is supported by planar RC frames which are connected with the principal substructures through RC slabs and horizontal metallic tubes. Between the substructures A3 and A4, simply supported RC slabs are placed at each floor. The resistant structures are realized by shear walls positioned mainly at the low levels and along the perimeter, while internally and at the top two floors, a series of rectangular and circular columns are disposed. Wide beams in the slab heights represent the majority of horizontal elements in the intermediate floors. Two elevator core, and the staircases are located in the substructures A2 and A6; while in A6 a passageway connects the Edifice B. The roof of the substructure A7 sustains the passageway to the main entrance.

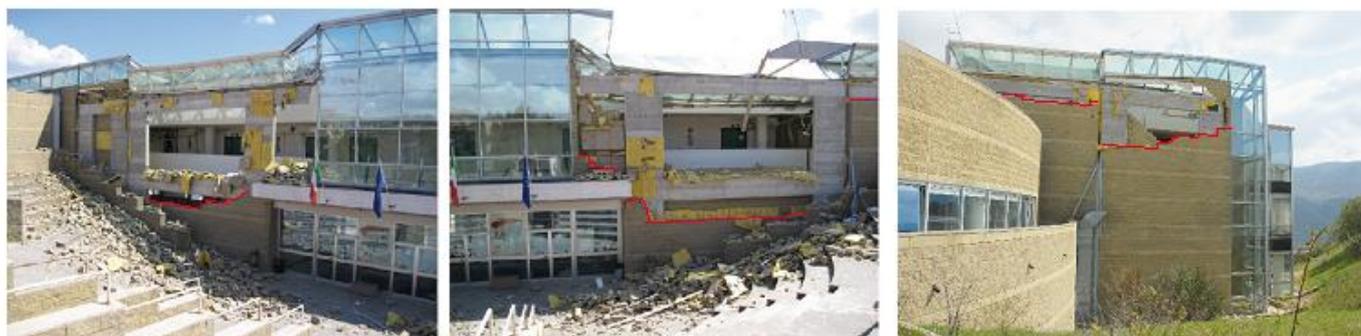
The main emblematic damage scenario was represented by the overturning of portions of split-face bricks walls on the principal façade (Figure 8). Different profiles of damage were visible in the external and the internal layer. Due

Figure 8. The front view of the principal facade, with the description of the damage profile (red line).

to the collapse of the split-face bricks the metallic tubes were seriously damaged, along the element and in the anchorage.

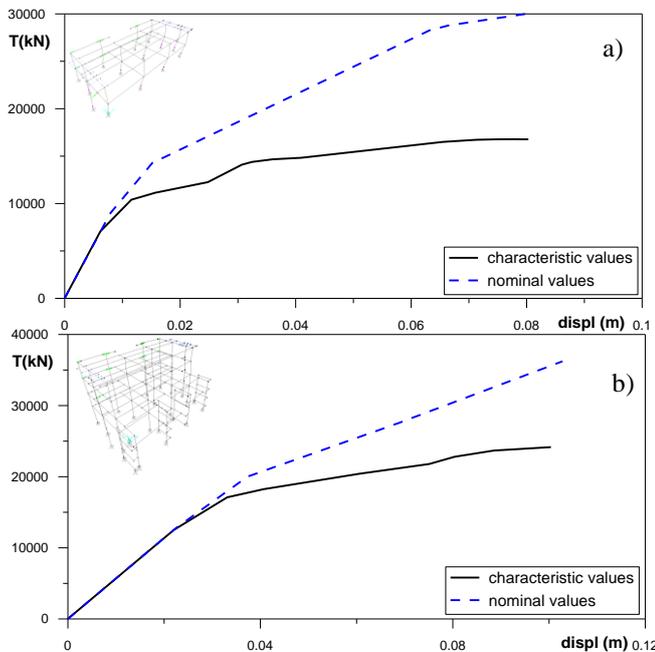
Figure 9. Structural capacity in out-of-plane facade direction using the material resistance characteristic values and nominal values in (a) FE reduced model (3rd and 4th floor); (b) complete FE model.

The effects of the assumed values for the material resistance on the nonlinear behaviour of the substructure A3 were examined through a pushover analysis. The capacity curves in the out-of-plane facade direction considering the mean and the characteristic values are reported in Figure 9. The analysis shows a significant increasing of resistance due to higher values of material strengths which does not correspond to an increasing of ductility, with the ultimate displacement capacity that remains constant.

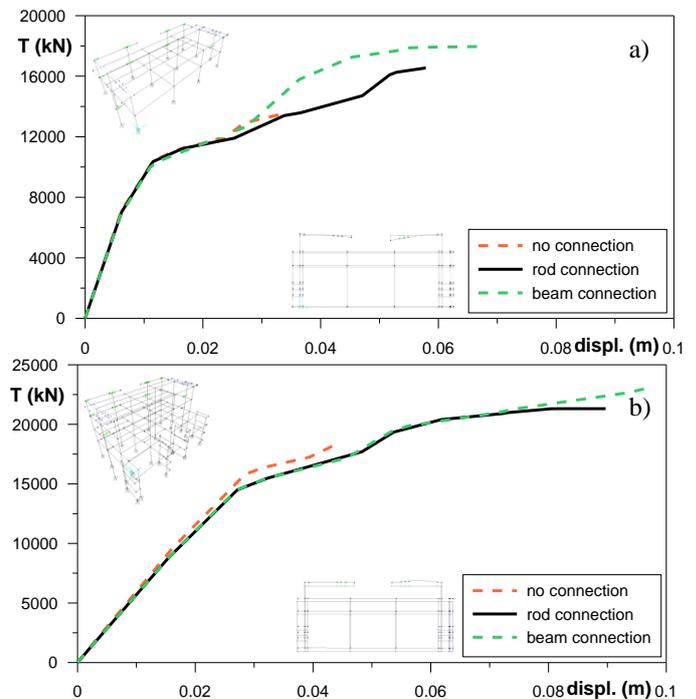
In Figure 10 the capacity curves of each model, following the different hypotheses are reported. The incremental forces applied in facade out-of-plane direction, are proportional to the principal mode shape in that direction. A significant difference between the case with facade connected with the tubulars or only with RC slab coupling can be appreciated.

Indeed, the tubulars sustain the shear walls of the planar frame, transferring axially the tension in the three-dimensional structure, assigning more ductility to the whole substructure.

Figure 10. Structural capacity in out-of-plane facade direction with different connections between the facade and the main structure: (a) FE reduced model (3rd and 4th floor); (b) complete FE model.

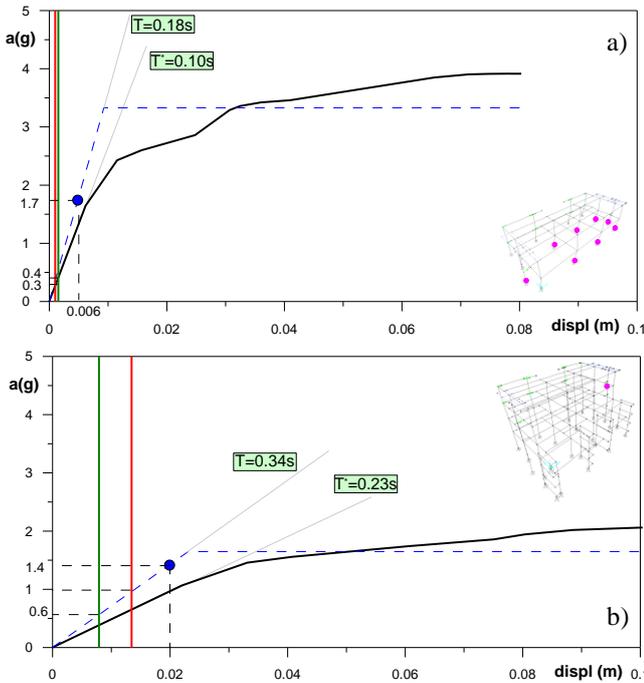
Taking into account the FE models with rod connections which result the more realistic, confirmed by some basilar deductions on the technical anchorage characteristics, the capacity curves are compared with the demand, in terms of maximum displacement, considering both the spectrum at Roio with soil type-C and the spectrum which included the local effects (Figure 11). In both cases the demand is quite low with respect to the ultimate displacement capacity.

Moreover, the demand is lower than the displacement required to achieve the first yielding in one element (represented as the blue point on the graphs), which occurred at the two external shear walls transversally oriented, the only ones that arrive at the top of the structure. Considering the complete model, the structure result more flexible and the demand, in terms of maximum displacement, increases. Taking into account the spectrum of local effects, the demands result rather close to the first yielding point.

This consideration can explain the anomalous cracked concrete found during the material testing, only in the shear walls.

Figure 11. Structural capacity in out-of-plane facade direction, with the displacement demand of main shock, taking into account the (a) FE model reduced at the 3rd and 4th floor, and (b) the complete FE model. The green line represents the demand of Roio soil C spectrum, the red line takes into account the local effects.

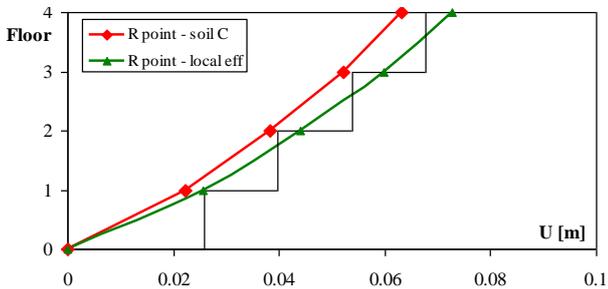
Some information on the non-structural elements behaviour could be obtained through the evaluation of inter-drift performance through linear analysis on the complete FE model of the substructure A3 (Figure 12). The values obtained both neglecting and considering the local effects were compared with the limitations defined by the Italian Code. While the lower grounds satisfy the limitations, the higher level, due to the stiffness reduction, exceed them.

Figure 12. Inter-drift evaluation in A3: comparison between the seismic demand and the Italian Code limitations (black line).
