# Ambient vibration tests on a monumental palace in Castelnuovo of S.Pio (AQ)

*Keywords: ambient vibration tests, natural frequencies, mode shapes, seismic vulnerability, monumental building, retrofitting interventions*

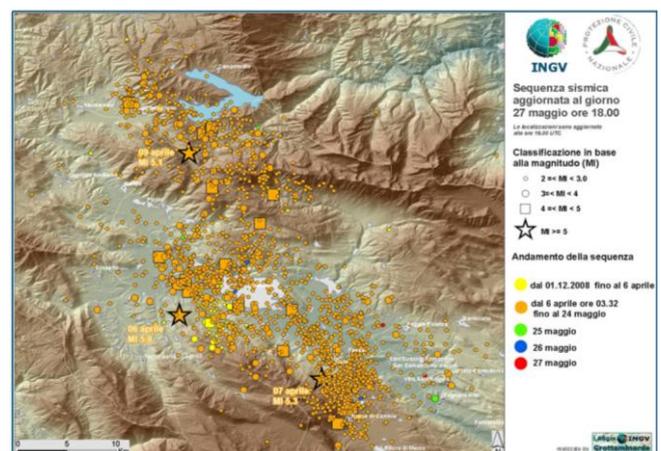
Figure 1. Seismic sequence and location of the L’Aquila earthquake epicenter (INGV)

The mainshock was rated 5.8 on the Richter Scale ( $M_L$ ) and 6.3 on the Moment Magnitude Scale ( $M_W$ ). Although the epicentre depth was not so deep, the seismic waves associated with shallow quakes produced very strong shaking and many damages; therefore, the mainshock was followed by many aftershocks (Fig.1).

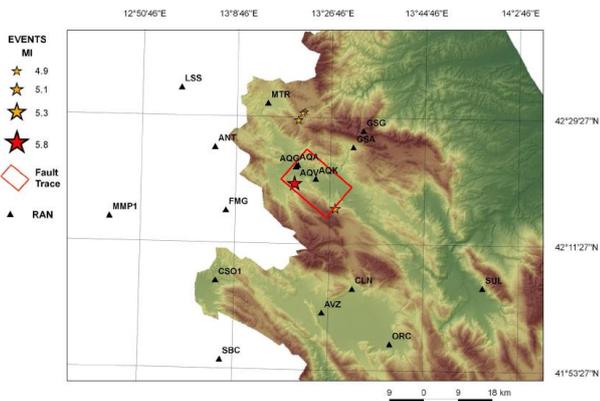
Figure 2. Fault geometry

The earthquake was generated by a normal fault, located in a valley contained between two parallel mountain along the direction North-South

(Fanale et al., 2009), with a maximum vertical dislocation of 25 cm and hypocentre depth of about 8.8 Km (Fig. 2).

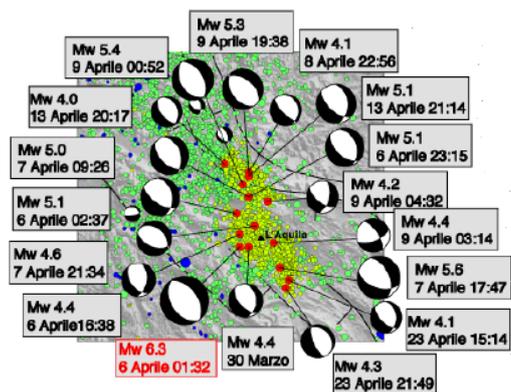
Figure 3. Sequence of seismic events occurred in the L'Aquila district (INGV)

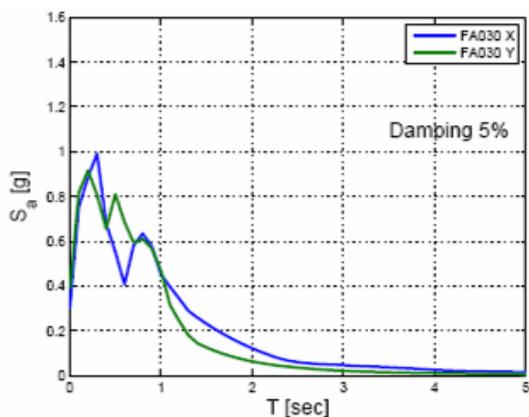
Figure 4. Elastic acceleration spectrum 4.3 km far from the epicentre

It was the third main earthquake recorded in Italy since 1972, after the Friuli event (1976;  $M_w=6.4$ ) and the Irpinia one (1980;  $M_w=6.9$ ). Furthermore, this seismic event was the strongest one among a sequence of 23 quakes having  $M_w>4$  and occurred between 2009 March, 30<sup>th</sup> and 2009 April, 23<sup>rd</sup> (Fig. 3), it providing strong motion recordings from accelerometer stations placed very close (4-5 Km) to the epicentre (Fig. 4).

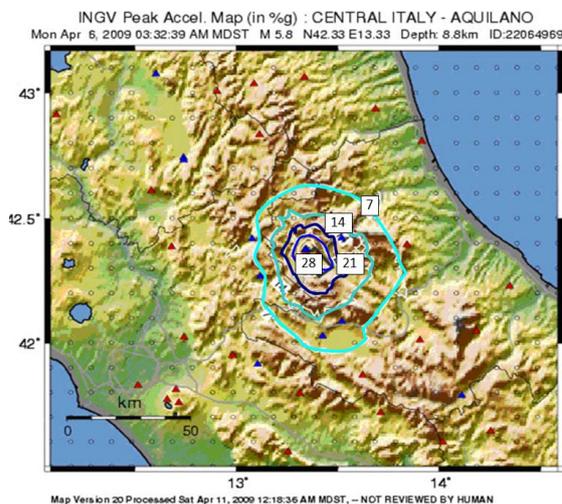
Figure 5. Peak Ground Acceleration (PGA) map for the  $M_L$  5.8 mainshock (INGV)

The main event was recorded by 56 digital strong motion stations, which are part of the Italian Strong Motion Network (in Italian *Rete Accelerometrica Nazionale*, RAN), owned and maintained by the Department of Civil Protection (DPC). The PGA map for the  $M_L$  5.8 mainshock on 1:32 GMT, April 6<sup>th</sup> is depicted in Figure 5.

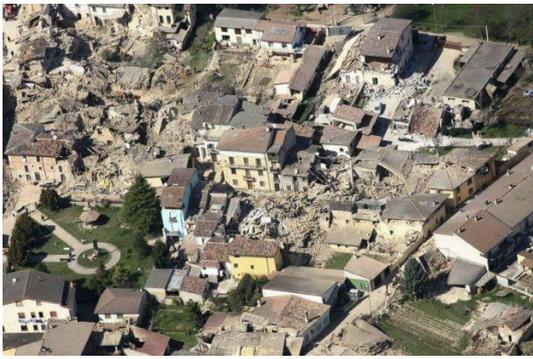
Figure 6. The historical centre of Onna after L'Aquila earthquake

The mainshock caused heavy damages in the centre of L'Aquila, where intensity value was reported varying between VIII and IX. Damages were even more significant in some villages located in the middle Aterno valley, where intensities as high as IX-X were experienced in Castelnuovo and Onna (Figs. 6 and 7). In total, 14 municipalities experienced a MCS intensity between VIII and IX, whereas those characterized by MCS intensity  $I$  larger than VII were altogether 45 (Galli and Camassi, 2009).

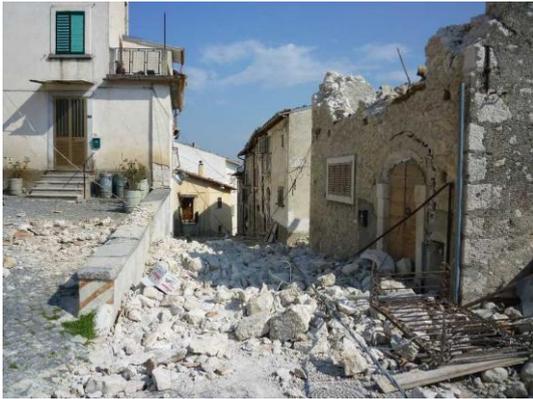
Figure 7. The historical centre of Castenuovo of San Pio after L'Aquila earthquake

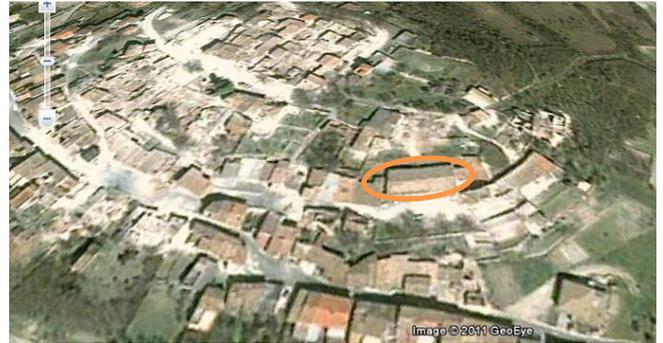
Figure 8. Bird's-eye view of the Sidoni Palace

The Sidoni Palace (bird's-eye view in Fig. 8) is a monumental building in the old medieval nucleus of Castelnuovo. It is an isolated building, having a regular and symmetric plan shape and developing on two floors (Fig. 9). The façade is also symmetric and characterized by regular openings and several architectural ornaments (Fig. 10). The entrance is constituted by an arch located in the central part of the façade.

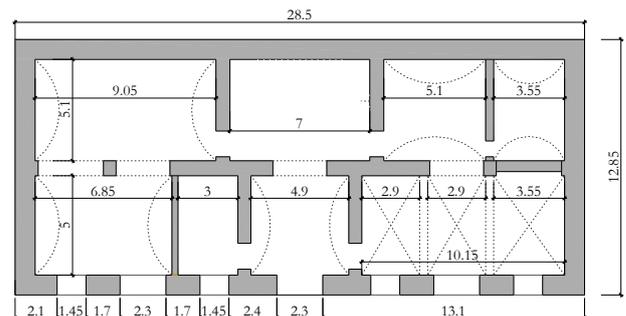
Figure 9. Plan view of the Sidoni Palace

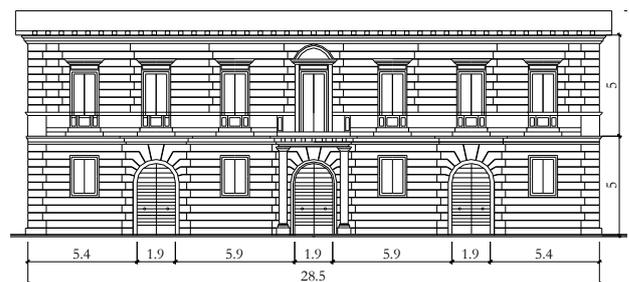
Figure 10. Front view of the Sidoni Palace

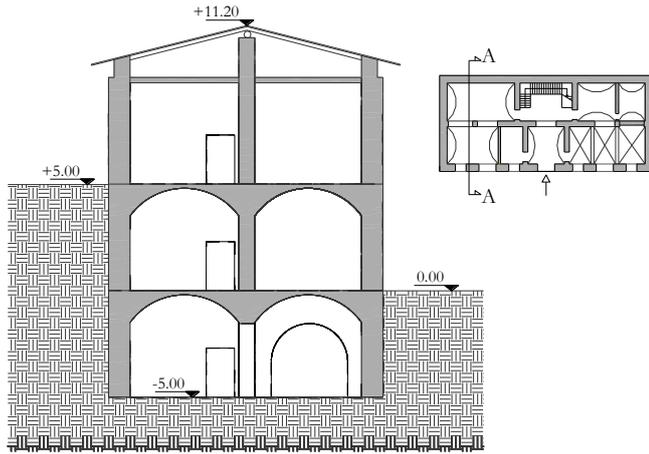
Figure 11. Transversal section of the Sidoni Palace

The building is a sack stone masonry structure with a ground floor developed on a rectangular surface of about 366 m<sup>2</sup> and covered by tunnel vaults. The first level floor is realised with steel profiles and hollow flat tiles, whereas a wooden pitched roof, covered by clay tiles and rebuilt after the demolition of the original vaulted roof, represents the building coverage.

The building has a basement floor and also the ground storey is on one side at contact with the

ground, as it shown in the transversal section of the palace depicted in Figure 11.

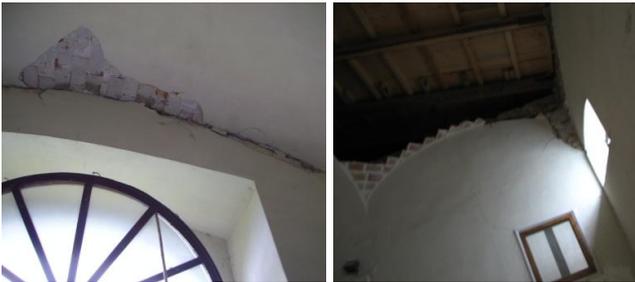
Figure 12. Damages occurred in the vaulted ceilings

After earthquake no damage was recorded in the building facade, whereas significant damages and collapses of part of masonry vaults took place inside (Fig. 12). Moreover, some of the steel floors at the first level of the building were destroyed by the earthquake, as illustrated in the building 3D views plotted in Figure 13.

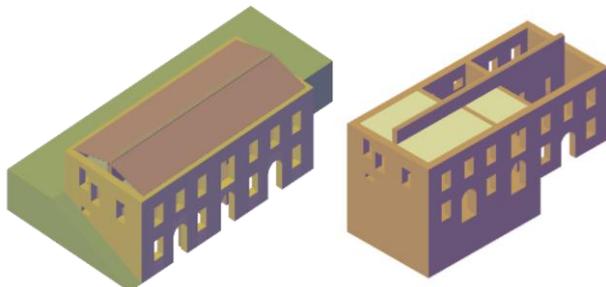
Figure 13. 3D views of the building

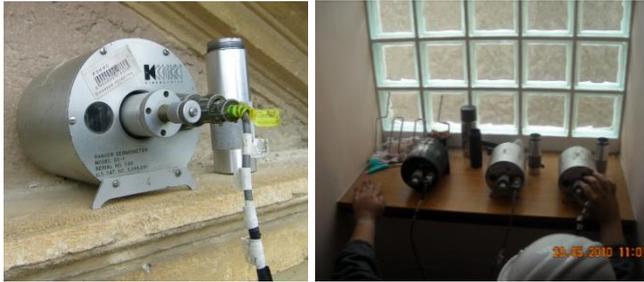
Figure 15. Equipment for ambient vibration measurements: the Ranger type seismometers

During the ambient vibration measurements of Sidoni Palace, three seismometers Ranger type Kinometrics product were used (Fig. 15) and the measured signal was amplified by four channel signal conditioner (Fig. 16). The amplified and filtered signals from the seismometers were then collected by high-speed data acquisition system (Fig. 17a), which transformed the analogue signals into digital ones. PC (Fig. 17b) and special software for on-line data processing have been used to plot the time histories of recorded velocities by the seismometers together with the Fourier Amplitude Spectra (FAS) of the response at any recorded point.

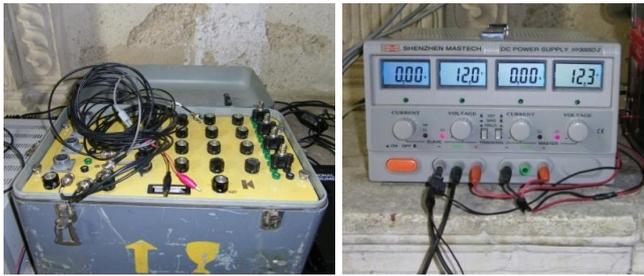
Figure 16. Equipment for ambient vibration measurements: Kinometrics product (a); four channel signal conditioner (b)

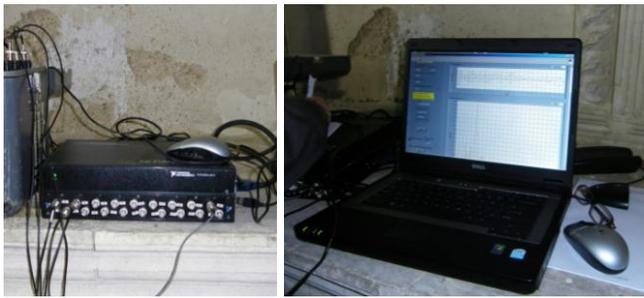
Figure 17. Equipment for ambient vibration measurements: high-speed data acquisition system (a); computer for data processing (b)

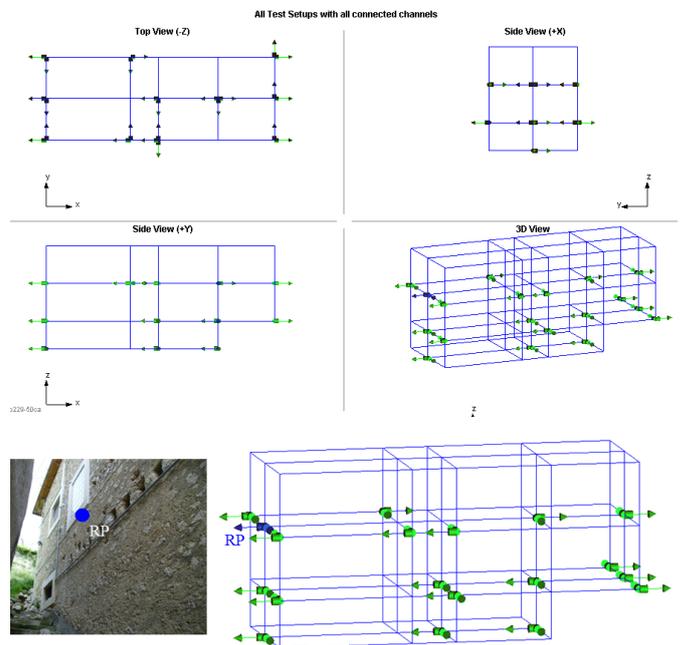
Figure 18. Top, side and 3D views of the geometry of the palace with positioning of the measuring points (RP is the blue point).

Measurements of the ambient vibrations on Sidoni Palace in Castelnuovo were performed along transversal and longitudinal directions of the building at selected structure points depicted

in Fig. 18 on the geometrical model of the structure generated by the ARTEMIS software (Krstevska et al., 2010). The total number of the performed tests was 38, they including also the dynamic calibration tests. The data sets consisted on records of velocity signals with duration of 100 seconds and the sampling frequency was 200  $S_a/s$ .

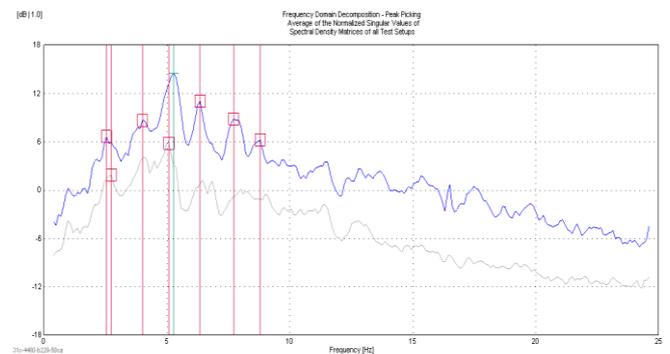
Figure 19. Peak Picking of the dominant frequencies of the Sidoni Palace

The Peak Picking of the dominant frequencies obtained by means of the ARTEMIS software is plotted in Figure 19.

From this figure it is apparent that the spectrum is characterised by several dominant frequencies. The vibration shapes at particular

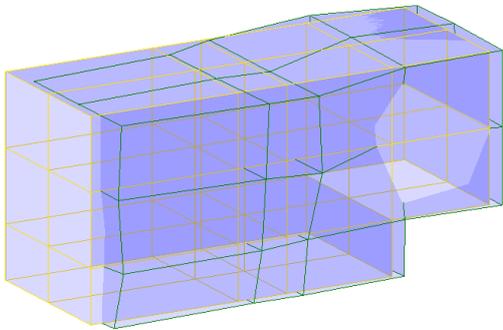
Figure 20. Vibration shape at a frequency of 5.08 Hz (transverse mode)

frequencies are given from Fig. 20 to Fig. 22. It is evident that the most clear frequency  $f$  for transversal vibration is at 5.08 Hz, while for longitudinal and rotational modes the frequencies of 5.27 Hz and 6.35 Hz are respectively noticed.

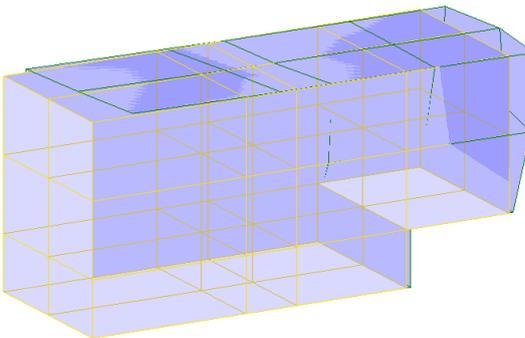
Figure 21. Vibration shape at a frequency of 5.27 Hz (longitudinal mode)

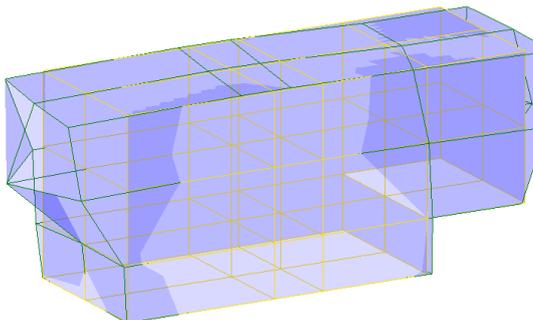
Figure 22. Vibration shape at a frequency of 6.35 Hz (rotational mode)

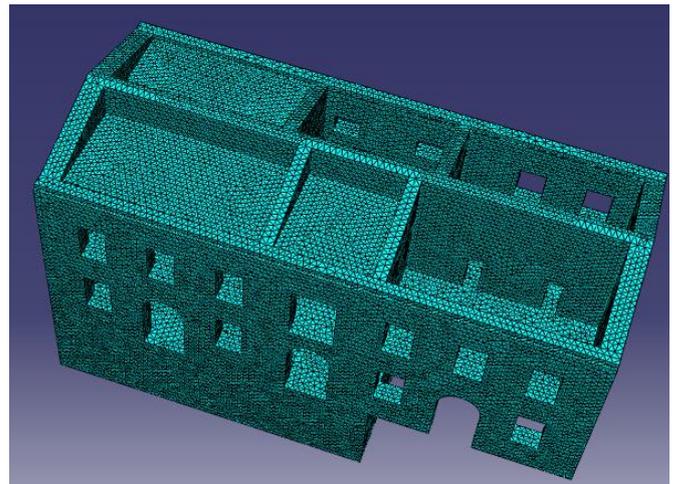
Figure 23. The ABAQUS FEM model of the palace

The whole masonry structure, fully restrained at its base, has been discretized by means of tetrahedral 3D solid elements, namely C3D4 (4-node linear tetrahedron) elements, having size length of 0.40 m (Fig. 23) (HKS, 2004).

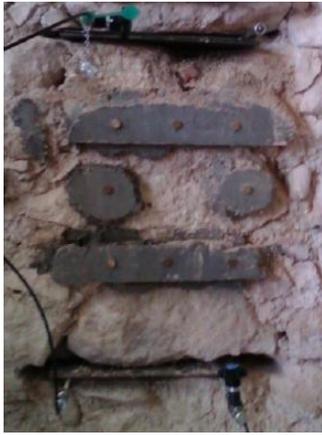
$A_C$ , Cutting area	882 cm <sup>2</sup>
$A_J$ , Flat jack area	778 cm <sup>2</sup>
Jacks distance	30 cm
$K_m$ , Jack constant	0.78
$K_a [A_J/A_C]$	0.88

Figure 24. Flat jack test on masonry: test set-up

As far as the material modelling is concerned, since the analysis is aimed at the structural global response identification, a continuum homogeneous material has been assumed. In addition, considering that the frequency analysis is purely a linear perturbation analysis type, only linear elastic properties of the masonry are required. So, the density has been assumed on the basis of the provisions of the Italian Ministerial Circular (M. C., 2009), it being equal to 19 kN/m<sup>3</sup>, while the elastic modulus  $E$  has been opportunely calibrated on the basis of flat jack tests performed on masonry (Fig. 24).

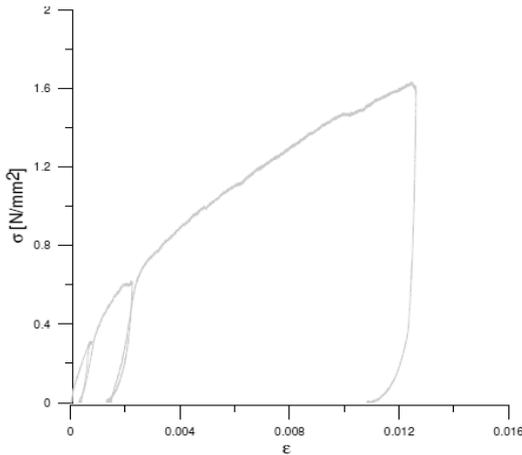
Figure 25. Stress vs. vertical strain law of masonry

The experimental in-situ test has provided the stress- vertical (Fig. 25) and horizontal (fig. 26) strain laws.

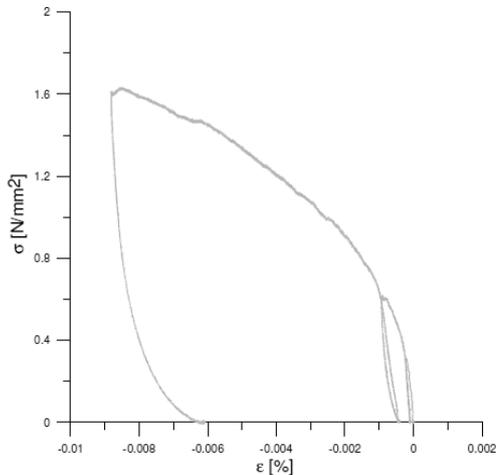
Figure 26. Stress vs. horizontal strain law of masonry

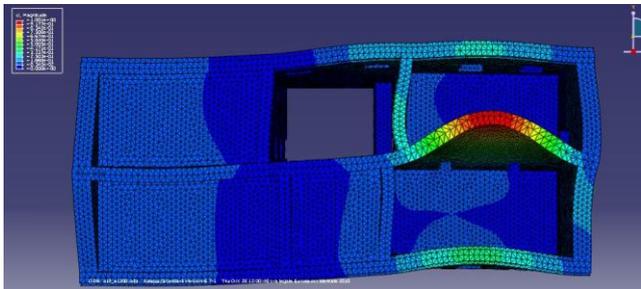
Figure 27. Transversal vibration mode ( $f = 5.06$  Hz) of the actual building FEM model.

The deformed FEM model configurations corresponding to the fundamental modal shapes are depicted in Figures 27, 28 and 29. From these figures, it may be pointed out that, according to the experimental results, the most deformable parts of the palace are masonry walls adjacent to the collapsed floors.

under numerical way by using the FEM model with fine mesh. It is worth to precise that the first global transverse vibration mode numerically founded had a frequency equal to 3.92 Hz. From the comparison, a reasonable agreement of results both in terms of vibration modes and natural frequency values is noticed (see Figs. 27-29).

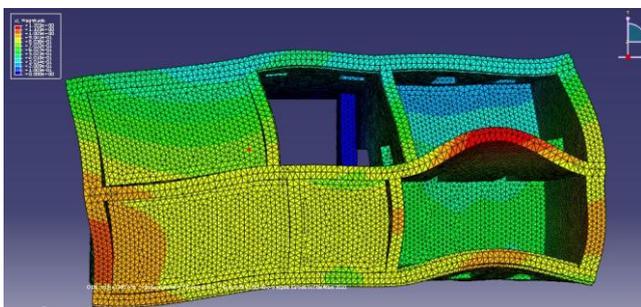
Figure 28. Longitudinal vibration mode ( $f = 5.17$  Hz) of the actual building FEM model.

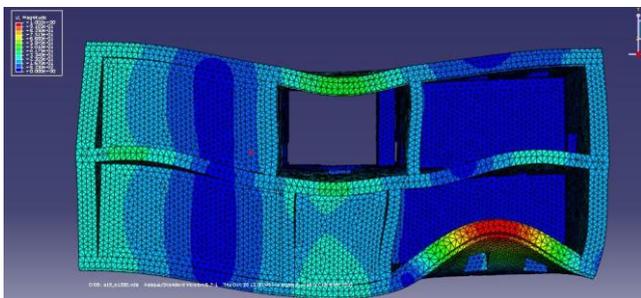
Figure 29. Torsional vibration mode ( $f = 6.59$  Hz) of the actual building FEM model.

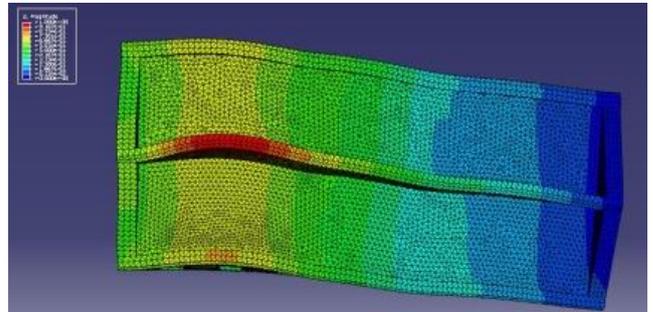
Figure 30. Transversal vibration mode ( $f = 4.00$  Hz) of the building FEM model before earthquake.

The global modal vibration shapes of the palace are illustrated in Figures 30, 31 and 32. It may be noticed that in this undamaged configuration the global mode shapes are clearly defined in each directions. In particular, the large transverse deformation of masonry walls due to the lack of floors in the damaged building is missed.

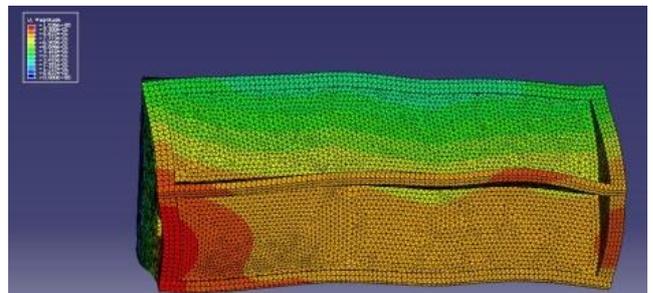
Figure 31. Longitudinal vibration mode ( $f = 5.32$  Hz) of the building FEM model before earthquake.

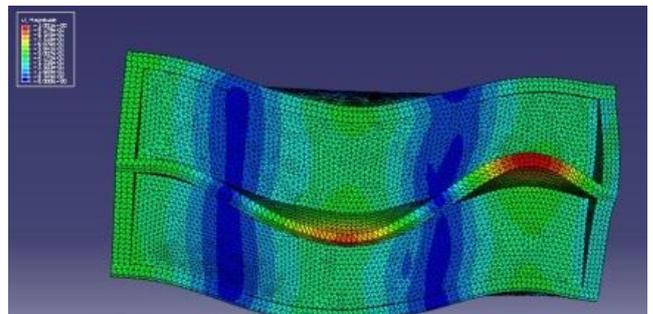
Figure 32. Torsional vibration mode ( $f = 7.09$  Hz) of the building FEM model before earthquake.

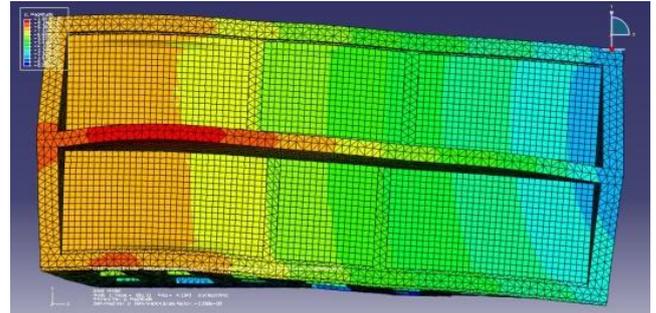
Figure 33. Transverse vibration mode ( $f = 4.15$  Hz) of the retrofitted building FEM model.

Afterwards, frequency analyses have been achieved on this retrofitted model, providing the modal shape depicted in Figures from 33 to 35.

By viewing the previous figures and also the results provided in Table 7, it is noted that the modal behaviour of the structure is drastically changed, since modal shapes are clearly defined, and the local modes coincide with the superior ones. In addition, the structural stiffness increases of the 6% for the transverse and longitudinal

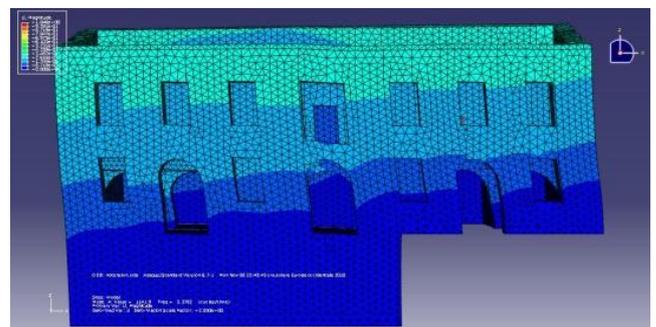
Figure 34. Longitudinal vibration mode ( $f = 5.37$  Hz) of the retrofitted building FEM model.

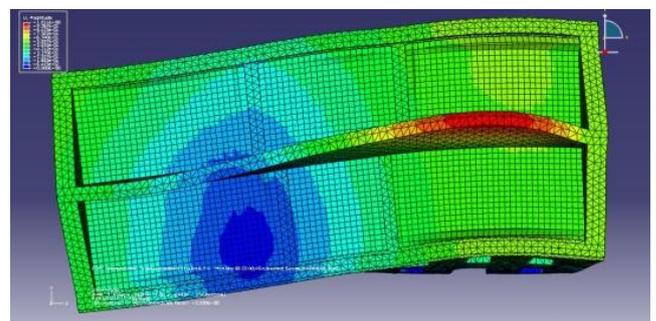
Figure 35. Torsional vibration mode ( $f = 6.41$  Hz) of the retrofitted building FEM model.
