Addressing ground-shaking-induced damage of the gas distribution network in the 2009 L`Aquila earthquake

Simona Esposito, Ludovica Elefante, Iunio Iervolino
Dipartimento di Ingegneria Strutturale, Università degli Studi di Napoli Federico II. Naples, Italy.

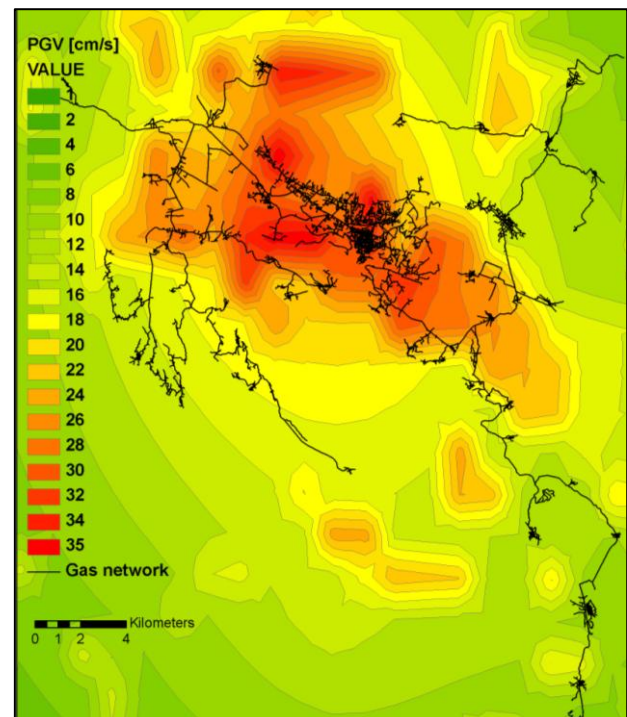
The ShakeMap processing system has provided PGV values as a grid of points with associated intensity values of the shaking parameter. Figure 1 shows the resulting PGV values, contoured for the maximum horizontal velocity (cm/sec) at each station, with contour intervals of 2 cm/sec.

Figure 1. Map of PGV (cm/s) contours relative to L'Aquila earthquake (from http://shakemap.rm.ingv.it) overlapped to the L'Aquila gas network.

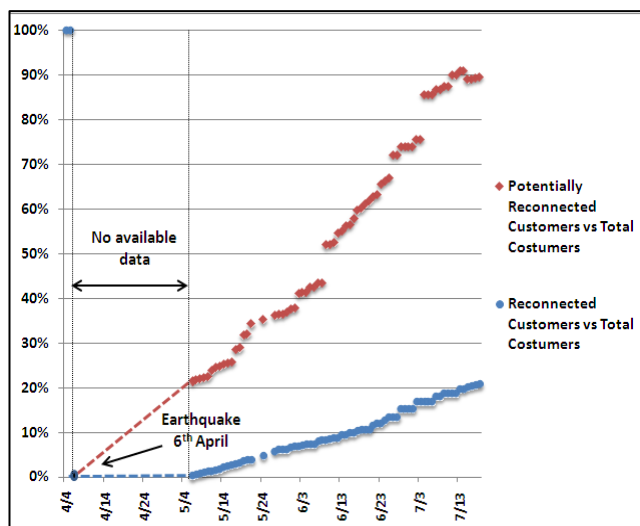
Figure 4 (red line) shows the percentage of the customers that could have been potentially reconnected to the network for all the four zones. In fact, a relative minor percentage of the end-users was reactivated to the service, (Figure 4, blue line), since the reactivation required a safe building for the supply; i.e., green tagging by the civil protection.

Figure 4. Percentage of the customers potentially reconnected (red line) and reconnected (blue line) to the networks for all the four zones in the months following the earthquake referring time period when data were available.

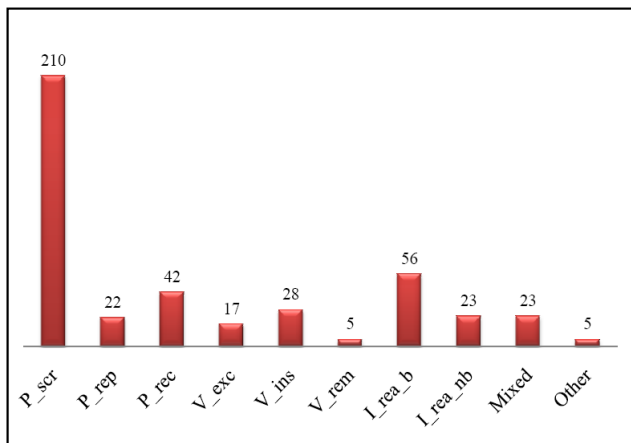
Figure 5 illustrates the number of interventions included in each of the considered macro categories.

Figure 5. Number of maintenance operations.

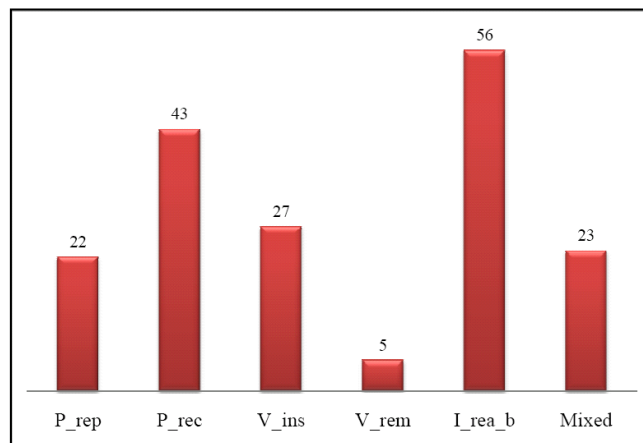
At the end of this process a reduced dataset consisting of 176 maintenance records was obtained. Figure 6 illustrates the composition of the reduced database used for damage analysis.

Figure 6. Reduced database of maintenance operations.

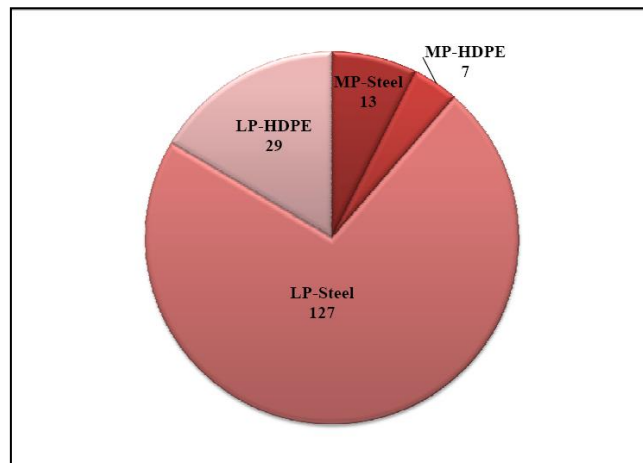
Figure 7 illustrates this operations included in the dataset distinguished in relation to pressure level and pipe material.

Figure 7. Dataset distinguished in relation to pressure level and pipe material.

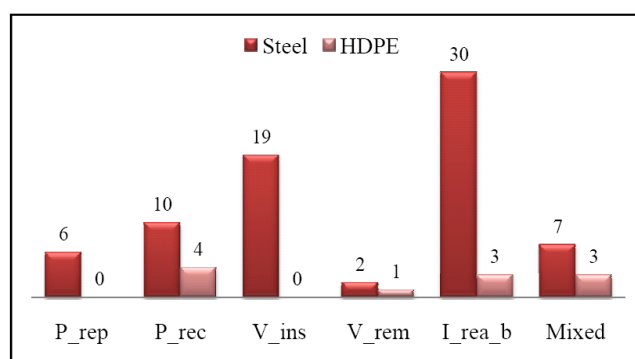
The repairs dataset used for repair ratio evaluation is composed of 85 data repairs distinguished in six macro categories, as illustrated in Figure 9. This dataset includes 8 repair operations on pipes operating at medium pressure and 77 on pipes operating at low pressure. As concern to material, only 11 repair operations included in the dataset were on HDPE pipes and the remaining 74 were on steel pipes.

Figure 9. Dataset for repair ratio evaluation distinguished in relation to pipe material.

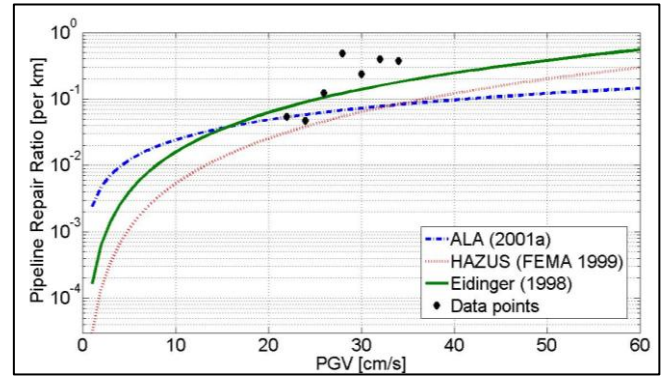
Results shows that the trend is somehow comparable with existing pipeline-fragility curves; although the fragility curves seems to be

conservative on respect to the observed damage, it must be highlighted that the scatter associated with the empirical fragility relations is quite high since those fragility curves have been obtained combining data from different kinds of pipes (e.g. ALA 2001a).

When looking at Figure 10 it is to recall that, as in some of the case studies reported in the literature, the repair rate following the L'Aquila earthquake incorporate the damage from both the ground shaking and the ground deformations, including PGD effects and surface rupture (ALA 2001b).

Unfortunately data available from L'Aquila earthquake does not make possible to derive an empirical curve because of the limited PGV range [22-34 cm/s]; anyway it could be useful to include repair data obtained in this work in a pipe damage database to develop new fragility curves.

Figure 10. R_R-PGV points compared with some fragility curves suitable for the L'Aquila gas network
