Damage Assessment and Reconstruction Planning in Poggio Picenze, following L'Aquila 2009 earthquake

Vincenzo Sepe, Enrico Spacone

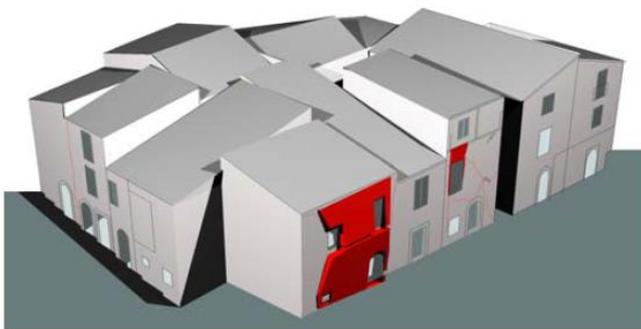
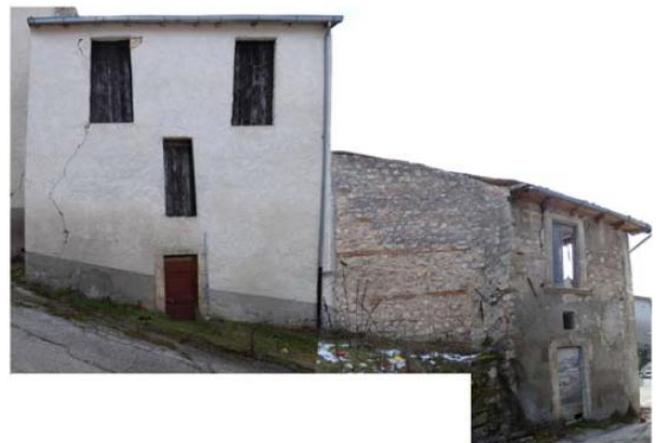
Figure 5. Partial toppling of an external wall

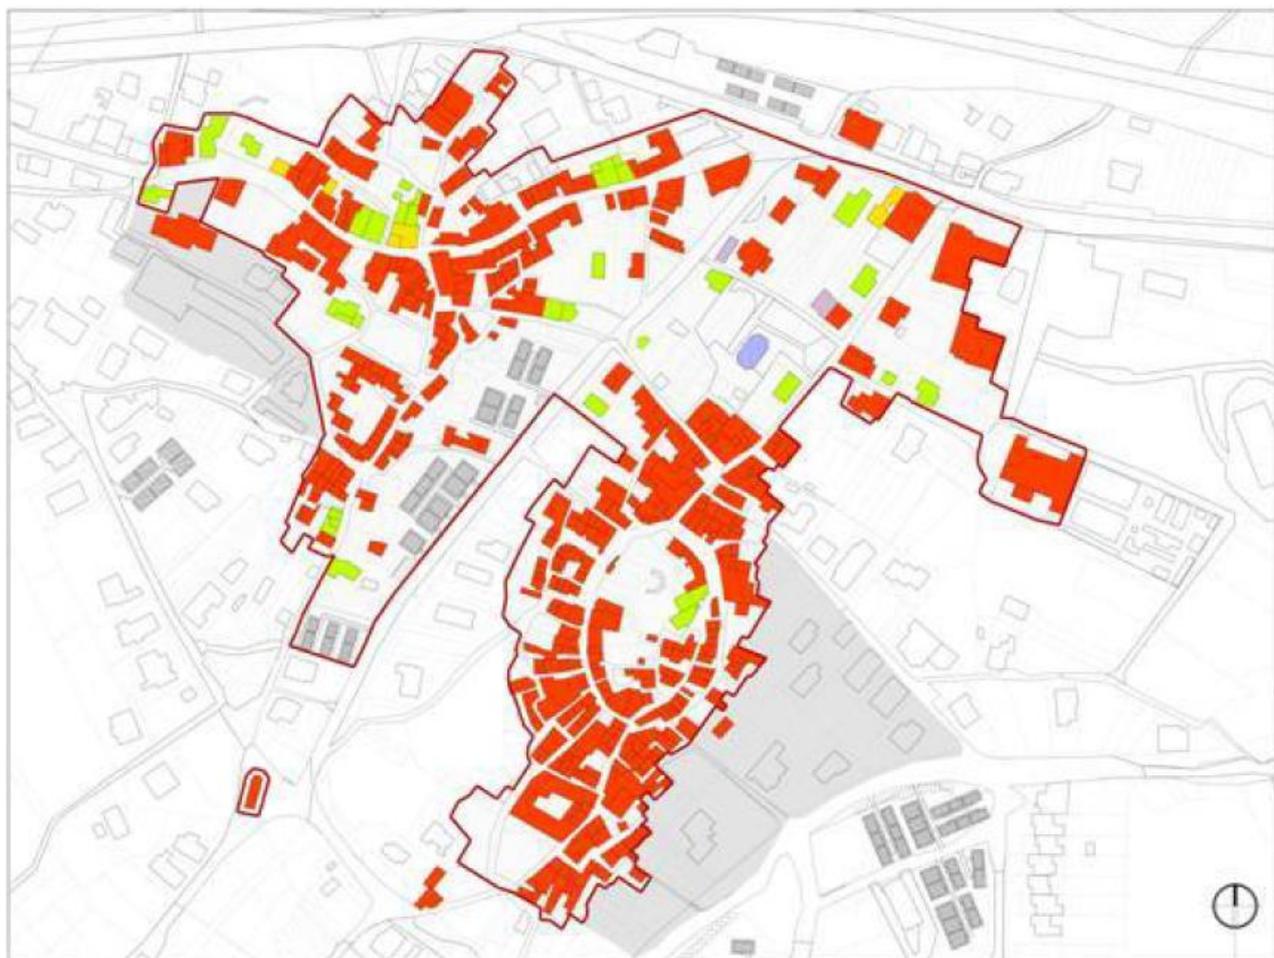
Figure 8. Historical center perimeter

This perimeter, reported in figure 8, clearly distinguishes the historical center where special rules need to be applied in order to assure a reconstruction process that respects the local building traditions and the pre-existing volumes. In the encircled area, in fact, the reconstruction cannot be performed at the scale of the single building or aggregate; according to recent guidelines for reconstruction, it has to be planned within a systemic approach, that should guarantee

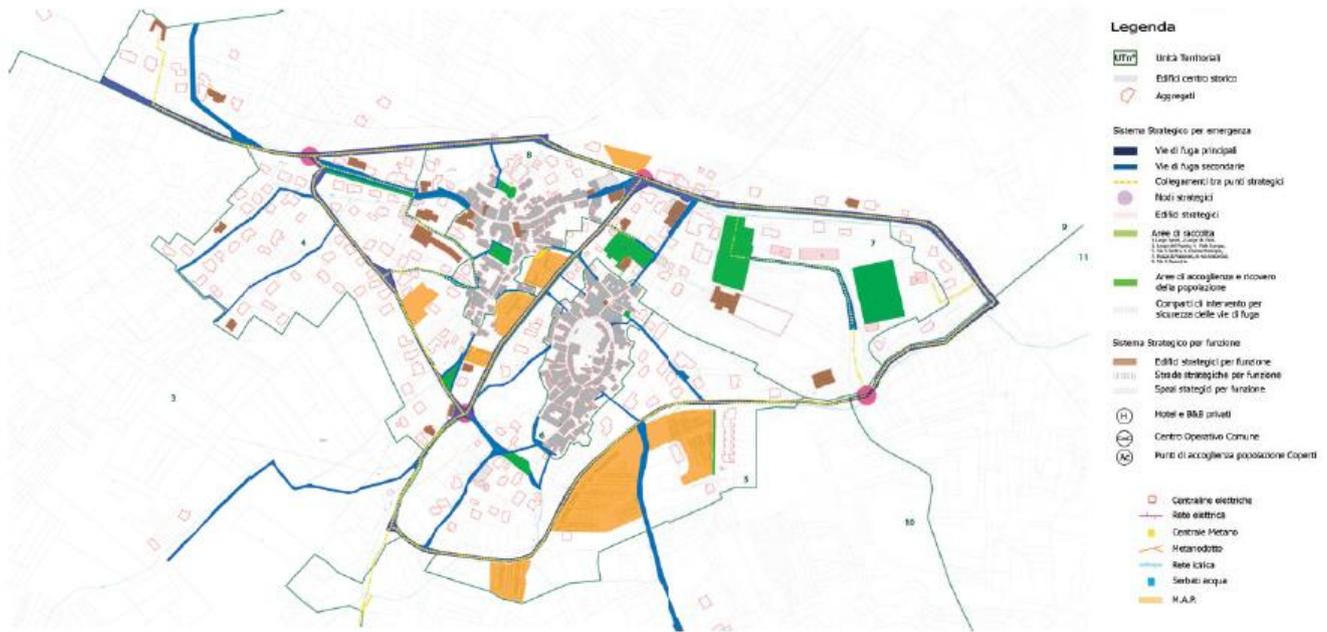
Figure 10. First draft of the minimum urban structure of Poggio Pienze

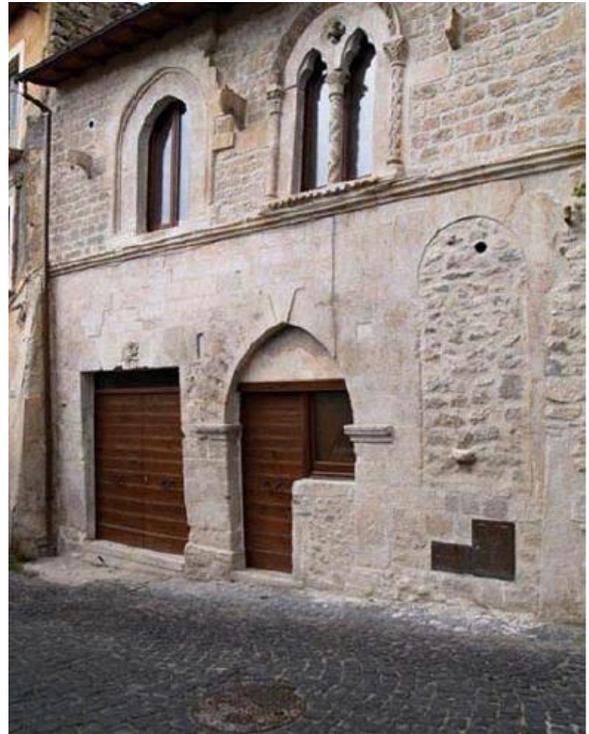
The so-called Medioeval House (fig. 14) is also worth mentioning: it is characterised by its distinctive mullioned window with two lights and ogive portal.

Figure 14. Medioeval House
