Edifice A of the Engineering Faculty of L'Aquila: earthquake damage scenario assessment through nonlinear analyses

Alfredo M. Ceci, Vincenzo Gattulli, Francesco Potenza

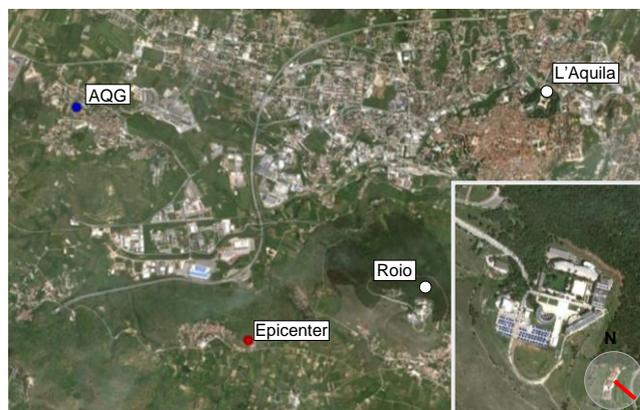
Figure 4. Locations of AQQ station and Roio with respect to the epicenter. In the frame the polarization (120°N) of seismic waves due to 3D local effects.

Here, the results of the site characterization are roughly synthesized in terms of elastic response spectra in Figure 7. In particular, firstly is taken into consideration the amplification from soil B-type to soil C-type provided by the National code (NTC08), then the amplification evaluated from the study of the site effects is taken into account in the spectrum with local effect (dot-dashed line in Figure 7). Moreover, a 3D effect which polarized the seismic waves was evidenced. In particular, the maximum amplification denoted in the closer station to the Faculty of Engineering, was obtained for azimuth close to 120°N, as reported in the frame of Figure 4.
